## Solid as a Rock: Poured Lead Joints in Medieval Masonry

Jennifer S. Alexander

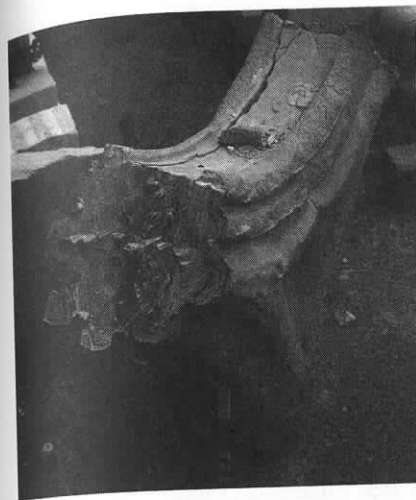
Figure 15.2 Salisbury Cathedral cloister; dismantled section of tracery showing lead joint in place (photo: author).

Masons constructing window tracery from sections of stone also used poured lead joints in construction. The recent restoration of the west window at York Minster found that the mortar jointing of the fourteenth-century tracery disguised lead joints.<sup>12</sup> Equally, the cloister arcade at Salisbury Cathedral was held together by lead joints, as the extensive restoration of the early 1990s showed (Fig. 15.2). Bases and capitals were linked to shafts and tracery by lead; it also provided a bed for the horizontal iron bars that supported the upper sections, and the tracery units themselves were further jointed in this manner. Tracery has long been recognized as a separate unit within the window, distinct from the moulding of the arch head, and modern architects introduce flexible joints between the tracery and the window arches to maintain this separation. By creating a monolithic structure, using lead joints for the tracery and then fitting the assembly into the window head with mortar, the medieval builder achieved the same result.

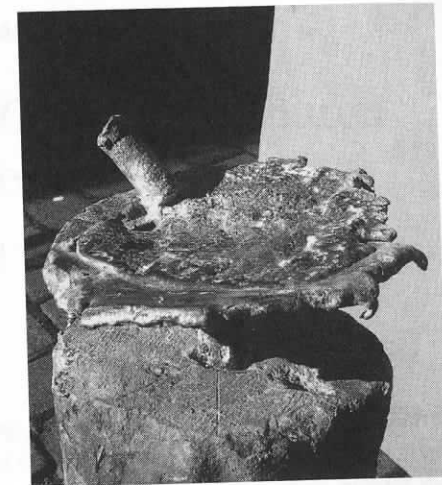
Figure 15.3 Limestone shaft from Lincoln Cathedral with partially dismantled lead joint. Note pouring hole on left (photo: author).

not too moist or spitting will occur when the hot lead reaches it. The lead has to be molten; in its pure state it melts at 327.5° C, and it is then highly mobile, which is why the clay collars are necessary, but it cools extremely fast and makes a tight bond with the stone that requires considerable force to break. In order to allow for a longer working time, the stone can be heated, and the building accounts for Rochester Castle in 1367–69 include payment for coal bought “for cementing the stones.” This process risks scorching the limestone, which turns it pink. Derek Phillips found evidence of such scorching on the tracery stones at York.<sup>17</sup> Medieval masons also dealt with this problem by carrying out the pouring in stages, creating a series of layers in the lead, and this gave them a longer working time (Fig. 15.3).<sup>18</sup>

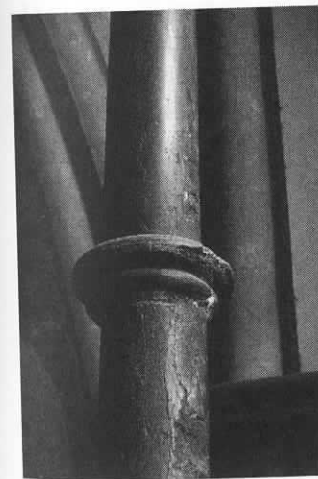
Figure 15.4 Rochester Cathedral presbytery; Purbeck shaft with poured lead joint and pouring hole evident on right (photo: author)

Purbeck shafts of any length will have been made up of sections, and these too have been found to be lead-jointed, but the processes at work are not always clear. At Rochester Cathedral, for example, the monolithic Purbeck shafts of the clerestory arcade in the presbytery have the pouring hole clearly visible at the rear of the shafts (Fig. 15.4), but other examples seen have been neatly trimmed to make the joint inconspicuous, and pouring holes have not been evident. Modern practice is to offer up these shafts into position supported by a frame, create the joint and then turn the shaft round so that the pouring hole is not visible. This may have also been a method used in the medieval workshop, but it is possible that the masons devised a spout-less form of pouring. In this, the clay collar would have been moulded into a cup shape around the joint, which would have needed spacers to hold it apart, and the lead poured into the cup would have been taken into the joint by gravity.
