EXTERNAL SPACES HEALTH & SAFETY INFORMATION SHEET

FACULTY OF ARTS – 5TH FLOOR BALCONY

Date survey undertaken: Friday 10th March 2023 10am

Prepared for
University of Warwick
Coventry
CV4 7AL

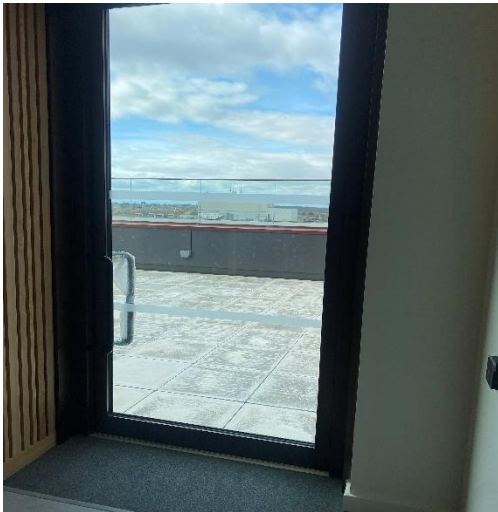
Main access door from lobby on fifth floor that and Salto access.

5.1 There is access on to the balcony from one main access door. This door is accessed via Salto from the 5th floor inner hallway. The balcony wraps around part of the building and can be directly viewed from multiple classroom spaces and the adjoining inner lobby area on that floor. (Please see plan attached). There are also two access doors from the adjoining classroom spaces that lead out onto the balcony. The wall between the classrooms can be removed to create one internal function space. There is currently no general access permit system in place for this outside space but we would recommend one be put in place.

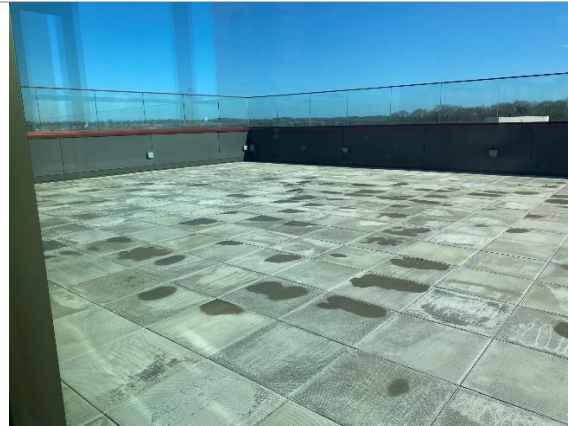
Main balcony area shown from classrooms that clearly shows edge protection, electrical point and ground area.

10.3 The edge protection has a ledge halfway up it is possible that occupants of the space, could lean, sit or stand on this ledge. This should be strictly prohibited and if possible, measures taken to prevent this being possible. Warning signs should also be considered.

10.6 There are external electrical points that are for use for appliances for events. Again, this should be built into risk assessments to check suitability and safety of proposed appliances that will be in use for events. Appliances should be placed in close proximity to electrical point to avoid trip hazards, extension leads should not be used that trail from inside the building.

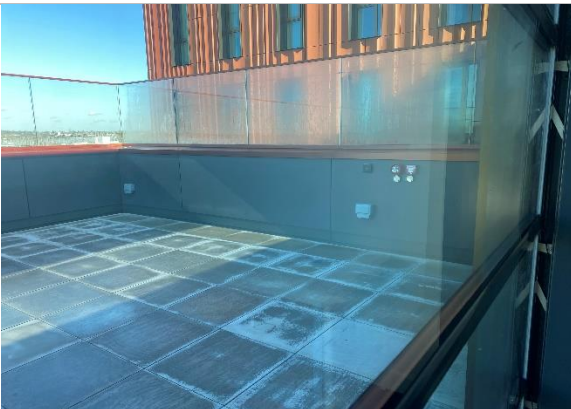
Fire detection point devices situated near main access door to balcony.

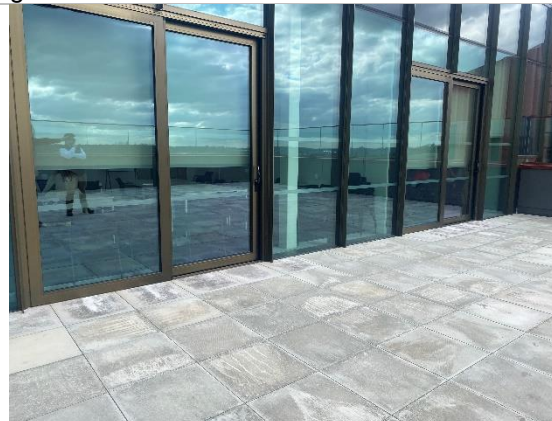
Double access doors that leads out from either classrooms or an open function space.

10.9 The furniture in the adjoining classrooms would need to be moved out should the space be used for as an open function space, manual handling training would be necessary for anybody moving furniture around and a suitable storage space would need to be discussed with the building manager.
