EXTERNAL SPACES HEALTH & SAFETY INFORMATION SHEET

WESTWOOD BANDSTAND

Date survey undertaken: Monday 13th February 2023 10am

Prepared for
University of Warwick
Coventry
CV4 7AL

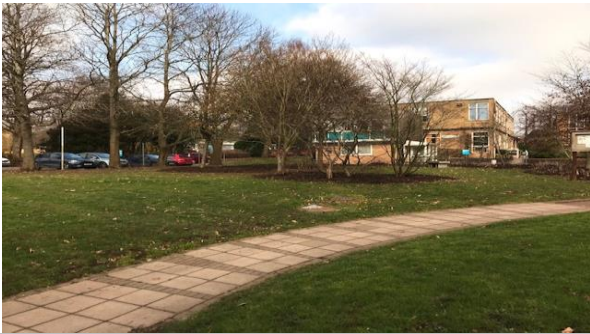
Photo taken from the west side of the site

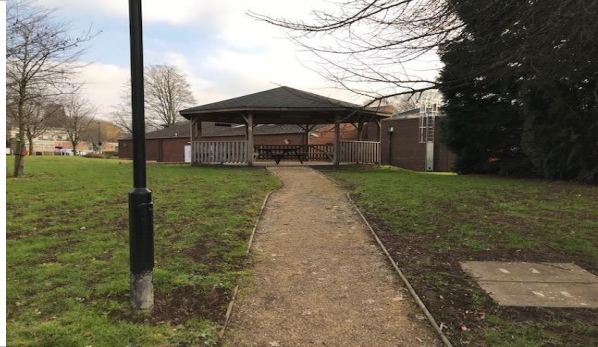
3.1 The site has been well maintained with low cut grass. The bandstand has recently been constructed on site and is in very good condition.

The Bandstand

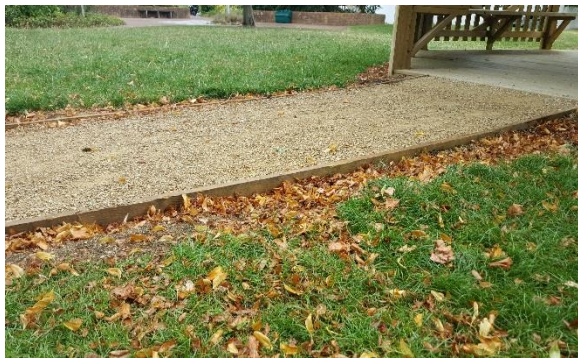
13.1 Several pathways have inadequate wood edge strips. People walking over the paths or children running around are likely to trip over these strips. Precautions need to be taken to avoid trips and falls.

Pathway edge strips- trip hazard

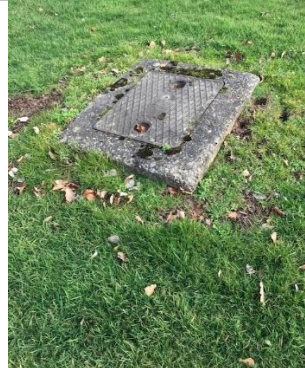
13.4 There is an inspection chamber cover located on site that is exposed around the edges and may act as a trip hazard. Precautions must be made around this area to avoid trips and falls.

Exposed manhole cover

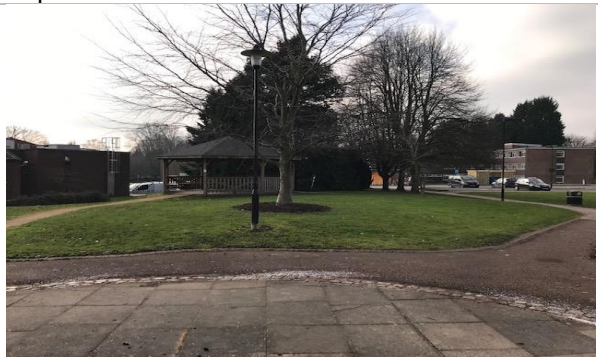
Photo taken from the east side of the site
